Quality Assurance and Source Inspection

Contract #: 04-0120F4Cty: SF/ALA Rte: 80 PM: 13.2/13.9File #: 1.28**WELDING INSPECTION REPORT****Resident Engineer:**Pursell, Gary**Address:** 333 Burma Road**City:** Oakland, CA 94607**Report No:** WIR-015702**Date Inspected:** 19-Jul-2010**Project Name:** SAS Superstructure**OSM Arrival Time:** 700**Prime Contractor:** American Bridge/Fluor Enterprises, a JV**OSM Departure Time:** 1530**Contractor:** American Bridge/Fluor Enterprises, a JV**Location:** Jobsite**CWI Name:** See below**CWI Present:** Yes No**Inspected CWI report:** Yes No N/A**Rod Oven in Use:** Yes No N/A**Electrode to specification:** Yes No N/A**Weld Procedures Followed:** Yes No N/A**Qualified Welders:** Yes No N/A**Verified Joint Fit-up:** Yes No N/A**Approved Drawings:** Yes No N/A**Approved WPS:** Yes No N/A**Delayed / Cancelled:** Yes No N/A**Bridge No:** 34-0006**Component:** SAS OBG**Summary of Items Observed:**

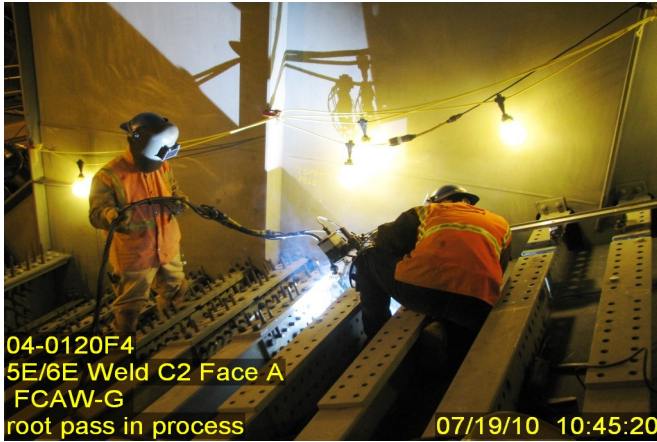
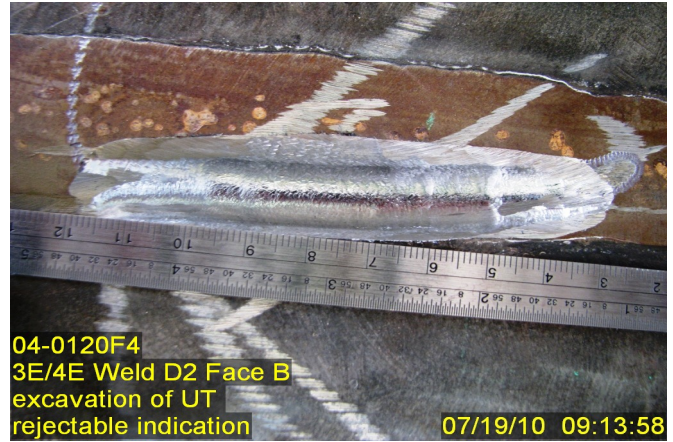
The QAI periodically observed the in process welding of OBG Field Splice 4E/5E Weld ID: C2, Face A per the FCAW-G process in the 3G (vertical) position by Approved AB/F welder Song Tao Huang (ID 3794). See photo below. QC Inspector Bonafacio Daquinag was present to monitor the progress and verify that the welding parameters were within the limits established by the approved welding Procedure Specification (WPS) identified as ABF-WPS-D1.5-3042B-1. The QAI observed that the welding parameters obtained by Mr. Daquinag appeared to be in general compliance with the contract documents. Welding Amperes = 237, welding volts = 24.0 and the travel speed was 237mm/min. Welding was in process for the remainder of this shift.
